ISTANBUL BRIDGE CONFERENCE 2020

"THE ENDURING LINK"

PROCEEDINGS

Bridge Analysis & Design & Construction

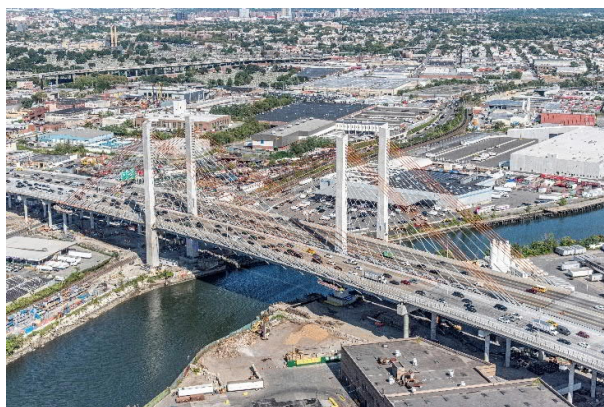
Figure 1 – Both Phases I and 2 Bridges Open

The new Kosciuszko Bridge is now opened to motorists, cyclists and pedestrians four years ahead of schedule and on budget. The bridge replaces a 1.1-mile segment of the Brooklyn-Queens Expressway over Newtown Creek with two parallel, modern and innovative structures each with a single-tower cable-stayed main span and prestressed girder approach spans. The signature structures provide a gateway between Brooklyn and Queens and reshape the skyline of these two New York City boroughs (Figure 1).

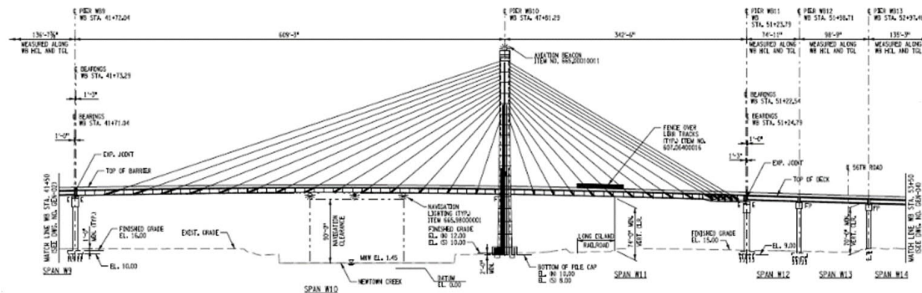
The Phase 2 Brooklyn-bound cable-stayed front span is 609-feet long with a 343-feet long back span. The span lengths and column locations were determined after much study in order to avoid impacting Newtown Creek which is a Superfund site (polluted area and requiring a long-term response to clean up hazardous material contamination), the Class-2 Inactive Hazardous Waste Site at the former Phelps Dodge Refining Site, the Long Island Rail Road tracks and the local street network below. Please see Figure 4 for the elevation view of the Phase 2 bridge.

Figure 4 – Phase 2 - Main Span

The single tower support is located on the Queens side of Newtown Creek and extends almost 200-feet above the roadway deck for a total height of 287-feet above grade. This is just below the maximum height allowed due to the bridge's proximity to LaGuardia Airport. The pylon legs are designed without a cross beam to tie the two columns together and they are behaving as independent cantilever beam/column. The single tower is comprised of two reinforced concrete tapered pylon legs that are designed

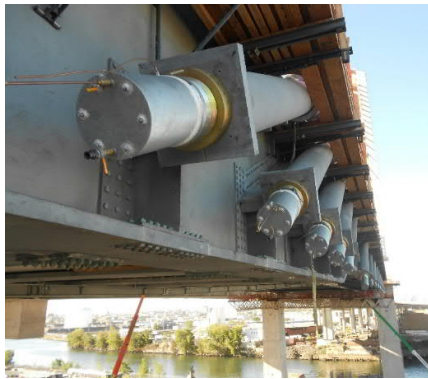
Figure 6 – Phase 2 Main Span Lower Cable Connection

The edge girders are designed to run continuously between the two pylon legs. To accommodate the cable and edge girder geometry, the cable connections are offset and located to the outside fascia of the edge girders. Outrigger cable connections (Figure 6) are bolted to the edge girders. Also, on a cable-stayed structure, high wind or rain events can result in high amplitude vibrations of the cables. Internal hydraulic dampers are installed at each cable to absorb this energy and dampen the vibration effects which minimizes the motion of the cable, reduces the fatigue effects and ensures the stability of the structure. The typical cable spacings are 40'-6" at the main span and 28'-0" at the back span. A closer cable spacing is used at the counterweight region at the end of the back span to support the heavy counterweight.

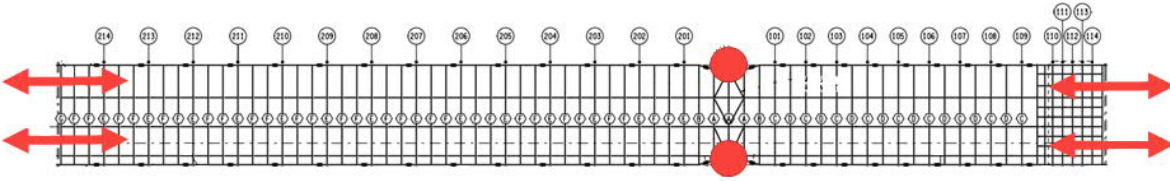
Multi-rotational disc bearings are utilized for longer service life. The superstructure boundary condition (Figure 8) at the pylon is a pinned condition and the superstructure is designed to allow longitudinal movement at the anchor piers.

Figure 8 – Bearing Boundary Conditions

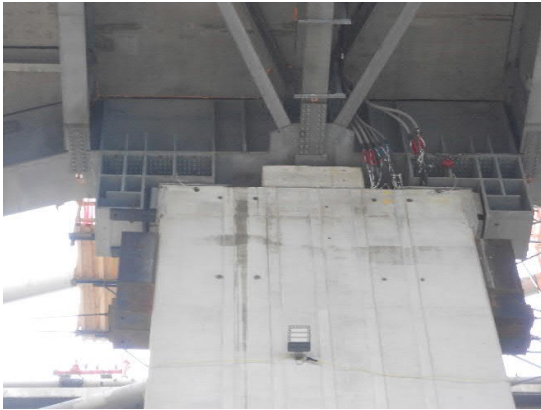
Figure 9 – Long. Restrainer

All main span superstructure longitudinal forces and some of the lateral forces like wind loads, braking forces and seismic forces are transferred from the superstructure to the pylon. In order to reduce the bearing size at the pylon, longitudinal restrainers (Figure 9) and lateral restrainers (Figure 10) are designed and used to transfer the lateral forces directly from the superstructure to the pylon. Concrete lateral restrainer blocks are used to guide the superstructure and transfer transverse forces from the superstructure to the anchor piers.

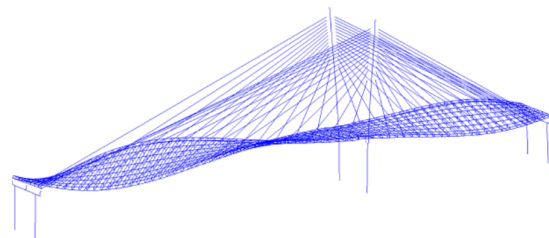
Figure 15 – First Torsional Mode

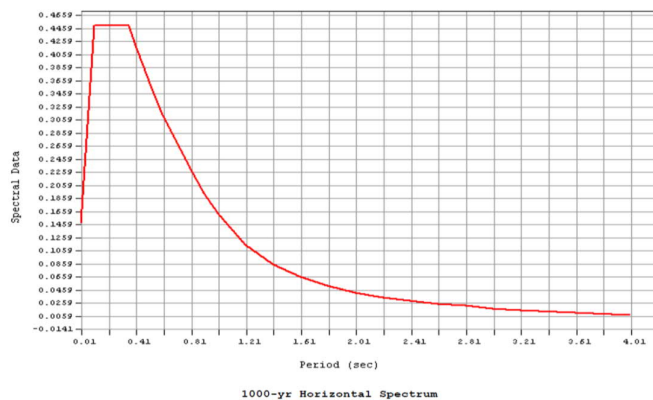
Figure 16 – RSA – Long. Dir.. (1000 yrs Return Period)

An elastic multi-modal response spectrum analysis was performed on the 3D finite element models for the approach spans combined with an inelastic pushover analysis. For the SEE, the inelastic pushover analysis was used to determine the response modification factors for each of the structural elements where damage is allowed. The allowable displacements were based on the strain limits set forth in these criteria for the SEE event. Once the response modification factors have been determined, they were applied to the results of the response spectrum analysis to compute the design forces for each supporting member. 50% of the design HL-93 live load was included in Extreme Event I (seismic load combination). However, inertia effects of live load were considered and was not included as part of the response spectrum analysis. 50% HL-93 live load was considered as static load case for Extreme Event I, and live load effects were ignored when neglecting them produces a conservative result.

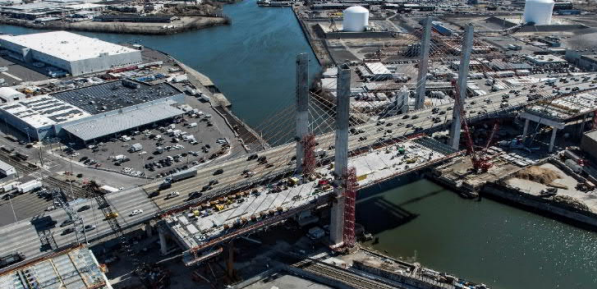
segments were constructed using jump forms and the construction was concurrent with the construction of the superstructure segments of the pier table and the superstructure segments adjacent to the pylon. A tower crane near the pylon was installed to assist the erection of the pylon and the superstructure segments in the pylon region. The main span superstructure was erected using the “balanced cantilever” method (Figure 19). The erection sequence attempts to minimize the dead load imbalanced condition between the back span and the main span.

Figure 19 – Phase 2 Main Span Construction

limit the pylon demands during the erection of the superstructure. Ballast was placed on the back span deck to limit the uplift forces in the temporary bent and to limit the pylon bending moments once the temporary bent was removed following the side span closure. Once the composite deck was completed, the deck ballast was removed and post-tensioning, utilities, drains, stayed cable dampers, expansion joints, barriers and the wearing surface were installed on the bridge per the erection sequence.

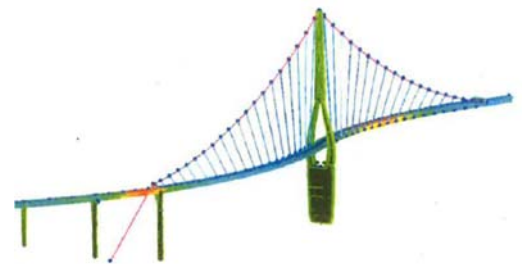
Fig. 3.2. General view of bridge

The free span of Scioto Bridge is around 153-meters with a total bridge length of 232 meters and a width of 4.3 meters. The cable systems use FLC120 for the main cables and tie down cable, FLC21 & FLC32 for the hangers and FLC50 for the restrainer cables which are connect the pylon and the deck to provide lateral stability.

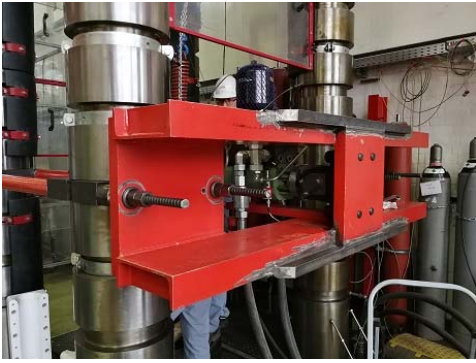
Fig. 5.1. Lateral piston for bending cycles

Hereafter some photos of the testing setup for FLC120.

During the tests, data such as number of cycles, cycle frequency, temperature, axial and lateral piston forces, and number of broken wires was monitored and recorded.

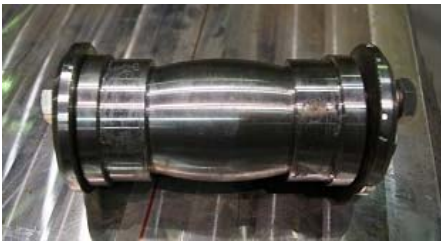
A critical issue related to the behaviour of the structure under live loads. In order to accommodate the deck movements experienced under live loads and limit bending of the hangers, Redaelli designed a spherical joint. Unfortunately this was rejected because of visual and architectural concerns and major modifications would have been needed to the already fabricated anchor plates.

Fig. 6.1. Spherical pin after test

Subsequently Redaelli designed and manufactured a set of pins with spherical shape in high strength stainless steel material which bore against a spherical washer. This solution was accepted with minor modifications in the structure. In order to test the durability and performance of this component under load, it was also included in the axial and bending fatigue tests. The test result was successful and the elements were free of any signs of damage after the test.

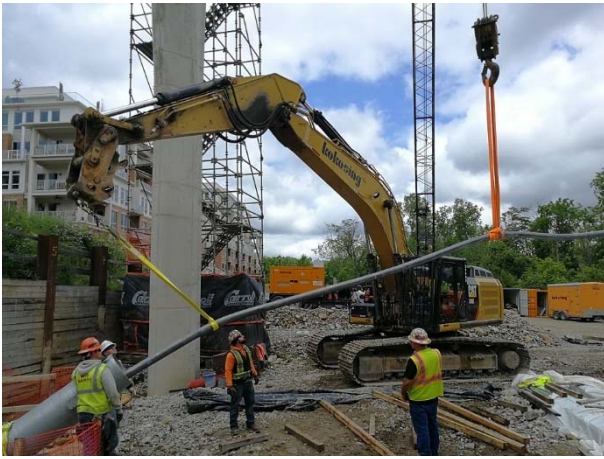
Fig. 7.1. Tie Down cable installation

Before the cable installation could begin, the pylon was constructed and self-sustained and the main part of the deck was installed and supported by temporary towers as per engineer's construction procedures. The first cable to be installed was the FLC120 Tie Down cable and after a first tensioning in order to give stability to the structure, the two main cables were uncoiled and installed to the mast and to the lower anchor points, using pulling machineries and devices. Since the height of the cranes was not enough to lift completely each main cable, the final part of uncoiling was performed with the assistance of an excavator machine.

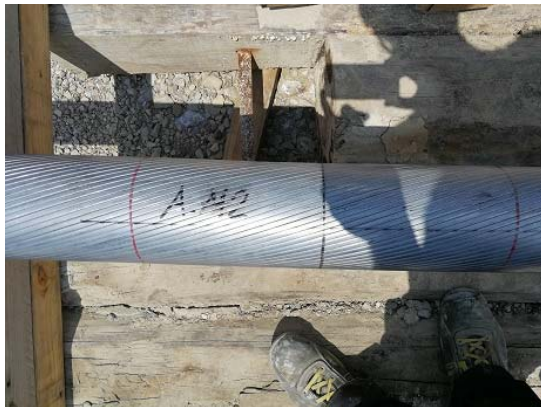
Fig. 7.3. Marking for clamps positioning

Before starting to lift and install the main cables, all the hanger clamps were installed while the cables were lying on wooden supports provided by the client. The clamps were secured to the main cables following the longitudinal and transversal marks made on the cables in the factory which ensured the correct position and alignment. The clamps were installed following a Redaelli procedure to tighten the bolts to 100% of the desired torque. Once all clamps were installed on the main cables, the cable was lifted and connected to the mast.

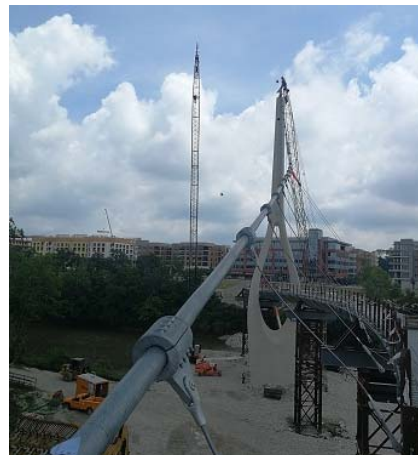
Fig. 7.6. Hangers connected loosely

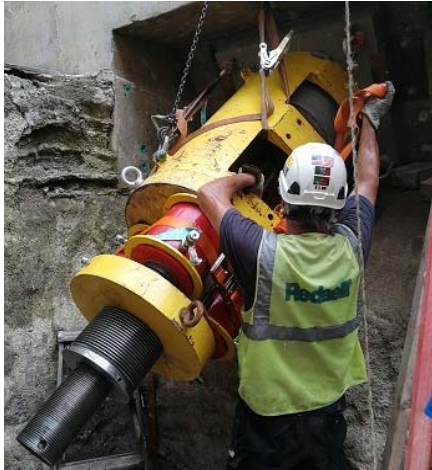
After uncoiling and installation of hangers, all hanger cables and Tie down cables tensioned several times by Redaelli personnel according to the engineer's tensioning procedure. The Tie Down cable was stressed using a tensioning system composed of one "stool" and No.3 jacks with capacity of 2000kN each, resulting in a total pulling capacity of 6000kN. The tensioning system for the hangers and the restrainer cables were composed of temporary rods and a beam pushed by No.2 jacks with capacity of 180kN each, for a total pulling force of 360kN on each hanger.

Fig. 7.7. Tie Down cable tensioning

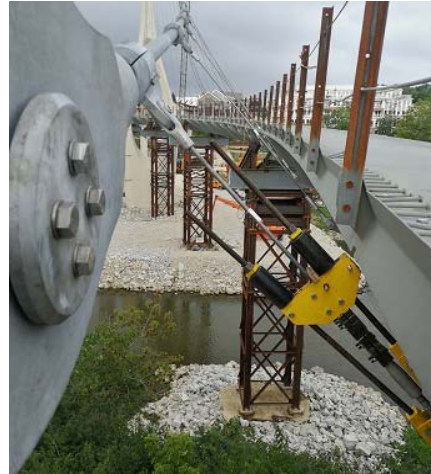
Fig. 7.8. Hangers tensioning

Another challenge was related to tensioning system of the hanger cables. Since the anchor plates have no room to connect the tensioning system in the usual ways, Redaelli designed a specific tensioning system which did not required any of the steelwork to be modified. The tensioning system was connected to the permanent pins of TBF sockets that were slightly longer than the standard pins without any visual or architectural issues. For the cable tensioning, one system was supplied for the Tie Down cable and four systems were supplied for the hanger cables. In addition, two tensioning systems were used to tension the restrainer cables inside the deck.

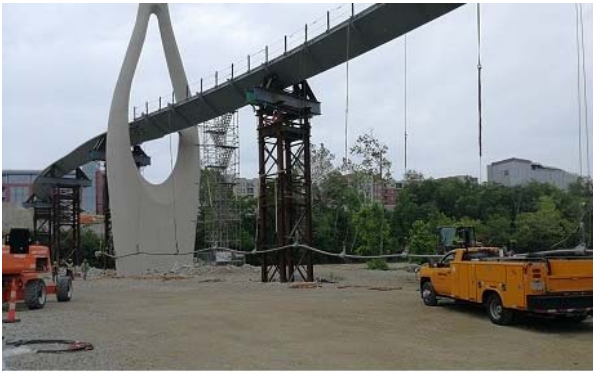
Weather conditions always play an important role in the site activities and the people involved are used to dealing with the non-standard weather conditions that can slow site activities. During the cable installation, strong rains to the North of Dublin significantly raised water levels in the Scioto river and caused the site area to flood which stopped site activities for several days. Unfortunately this occurred during a critical phase when the main cables were uncoiled and placed on the ground before installation and fixing of the hanger clamps. Thanks to the quick thinking and immediate action by personnel on site, suitable wooden support was prepared before the flood hit which kept the cable above out of the flood water and avoided possible damage.

Fig. 8.1. Main cable temporarily lifted

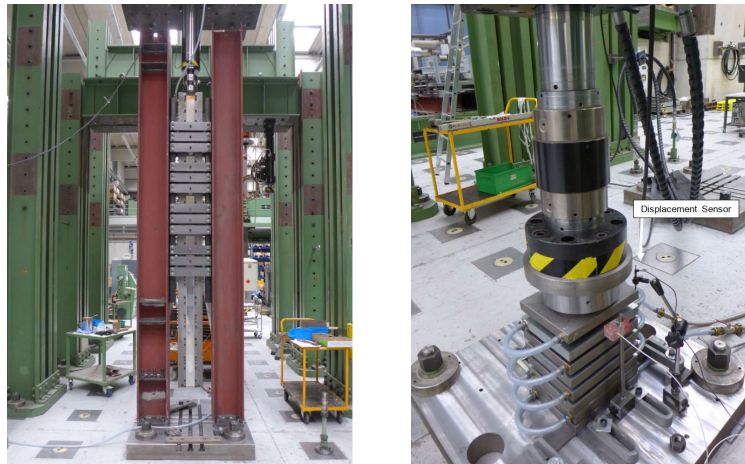
Dynamic tests regarding resistance to fatigue and wear of the product represented by a test method for components relate in particular to sliding components used for modular joints. Wear and load impact challenge both the durability of modular expansion joints respectively maintenance of such joints as the related sliding bearings and sliding springs are considered as replaceable parts according Table 2 of EAD 120113-00-0107. Category “B” applies for these components, which shall provide an intended working life not less than 0,5 times the intended working life of the kit relating to minimum 25 years for these components based on recommended 50 years for the kit (overall expansion joint). Apart of the large accumulated movements related to such long working life it is clearly related to very high number of load cycles. Accordingly the second phase is recommended to cover unlimited fatigue life by testing for 5×10^6 cycles. Mageba has tested sliding springs and sliding bearings according to phase 1 described in EAD 120113-00-0107, Annex D for up to 9 km of accumulated sliding path with double amplitude of up to 1 m (compare Fig. 2a)) proving stable and low friction as well as succeeding without any sign of wear. Subsequent the sliding bearings have been tested (compare Fig. 2b)) according phase 2 for fatigue loads adjusted with results from dynamic assessment based on field tests (compare 6.). Such testing for 5×10^6 cycles resulted in less than 2,4 % change of height. Both phases require active temperature control of the entire test setup.

Fig. 2) a) Wear test setup and b) fatigue test setup both with active temperature control

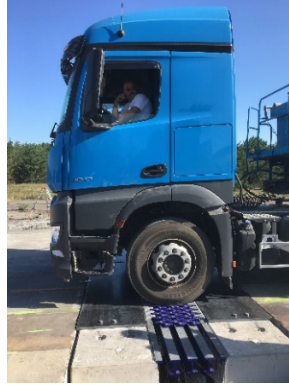
Fig. 3) Dynamic assessment and field test setup

Dynamic assessment and field test relate in particular to the dynamic behavior of expansion joints, which are identified by overrolling tests per each type and system applicable to a range of similar behavior. Especially vertical dynamic impact, upswing, transfer of horizontal to vertical load and horizontal response ratio factors have significant impact on the loads that need to be considered for fatigue calculations as well as for loads applied in tests. Apart of EAD 120113-00-0107 [16] for modular joints all other EADs [11 to 15] related to expansion joints for road bridges provide default values, which can be applied instead of values identified by overrolling tests. Nevertheless results from dynamic assessment and field tests can be applied for most types almost identical to modular joints. For all such tests it is vital to fulfil requirements given by the applicable EAD in detail like in EAD 120113-00-0107, Annex E for modular joints. In particular all dynamic influences need special attention like evenness of medium quality ensured for the pavement minimum 30 m before and behind the installed expansion joint specimen. Proving that criteria requires defined prepared pavement as well as very special expertise and equipment in the field of roads surface survey and data processing. Similar applies to the dynamic measurements from different truck impacts on various speed, full

acceleration and full braking. Field measurements by the use of strain gauges, accelerometers and laser signals as well as statistical data evaluation requires particular expertise, which can be offered by few experts especially if such should cover experience related to dynamic assessment of expansion joints. It took mageba with various partners several weeks of test campaign to conduct these tests for various types of expansion joints such as nosing (single seal), cantilever finger and modular joints with and without noise reducing elements (compare Fig. 3)).

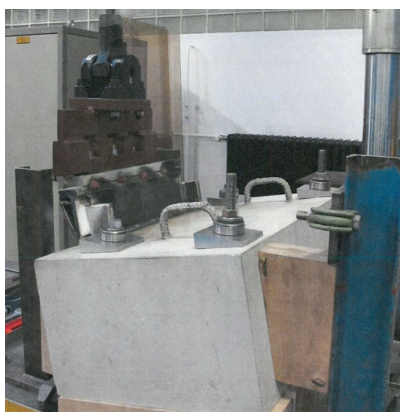
and system of expansion joint. Particular care is required regarding simulation of the wheel print for the load application (compare Fig. 5).

Fig. 5) Fatigue testing of anchorage

Assessment of resistance to fatigue by testing relates in particular to details, which are difficult to be assessed by calculation only like the anchorage of expansion joints to concrete structures. Taking into account that these elements cannot be replaced and an intended working life of 50 years is anticipated, the number of load cycles should cover unlimited fatigue resistance by testing for 5×10^6 cycles. Again test loads shall be based on fatigue loads adjusted according results from dynamic assessment based on field tests (compare 7.) in order to cover the effective behavior of the tested type

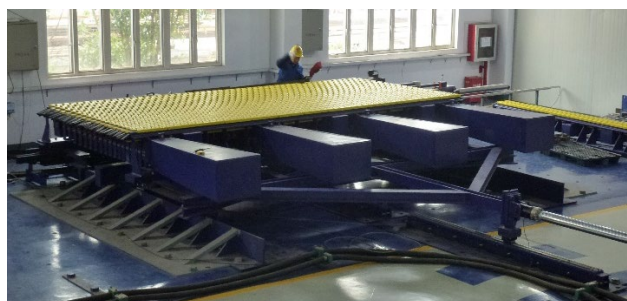
Fig. 6) Assessment of movement capacity

Assessment of movement capacity is required for all types of expansion joints for road bridges and is specified in EAD 120109-00-0107, Annex D.3 (referenced by the other EADs). The test shall cover full movement capacity of the expansion joint in several cycles partially combining longitudinal, transversal and vertical displacement as well as rotations if relevant. In particular for very large movement capacity such testing is very demanding and requires very special test equipment. Mageba has used such equipment to test 18 gaps modular expansion joints with and without noise reduction elements and movement capacity of up to 1800 mm in longitudinal, 900 mm in transversal and 90 mm vertical direction (compare Fig 6)).

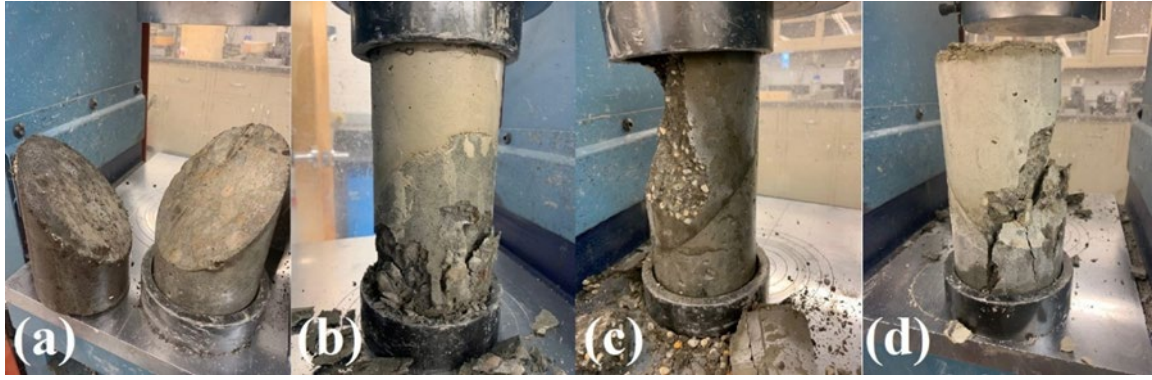
Another observation was in failure modes in which materials showed all possible failure patterns, including bond failure, repair material failure, substrate concrete failure, and a combination of the three failure modes. Figure 4 illustrates the typical failure modes observed in the slant shear test. In this study, in four out of eight repair materials (M1, M2, M3, and M6) bond failure was observed in one specimen only. Other materials (M4, M5, and M7) experienced bond failure at early ages but not at late ages. M8 is the only material having bond failure at both early and late ages. Based on Table 4, M5 and M8 had the highest number of bond failures. M2 is the only material having only repair or substrate failure modes. M2 also had the highest number of substrate failures, long with M4. M3 had the highest number of repair material failures.

Figure 4: Failure modes observed in the slant shear bond strength tests: (a) Bond failure, (b) Substrate concrete failure, (c) Repair material failure, and (d) Combination of failures

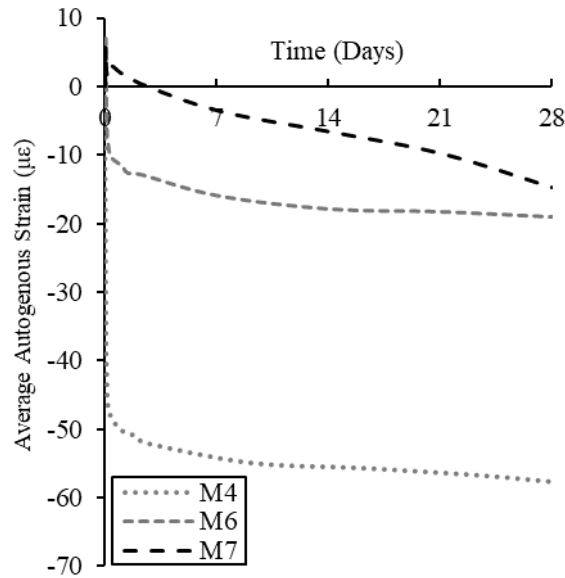
Figure 5 shows the average autogenous shrinkage of the three materials at different ages.

Figure 5: Average autogenous shrinkage of materials 4, 6, and 7 at different ages

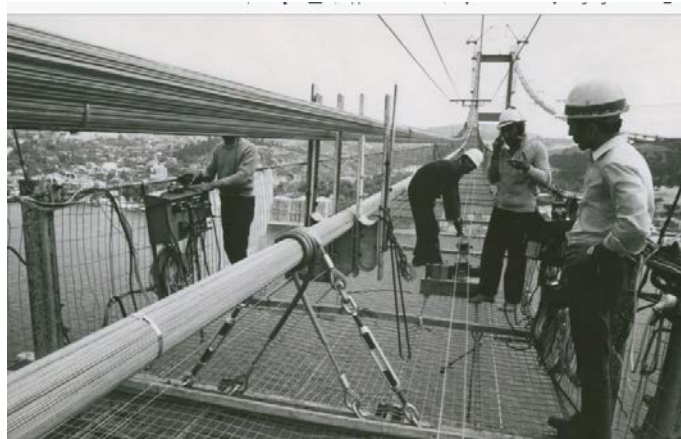
Figure 3: Original cable construction of the first Bosphorus Bridge using the arial spinning method

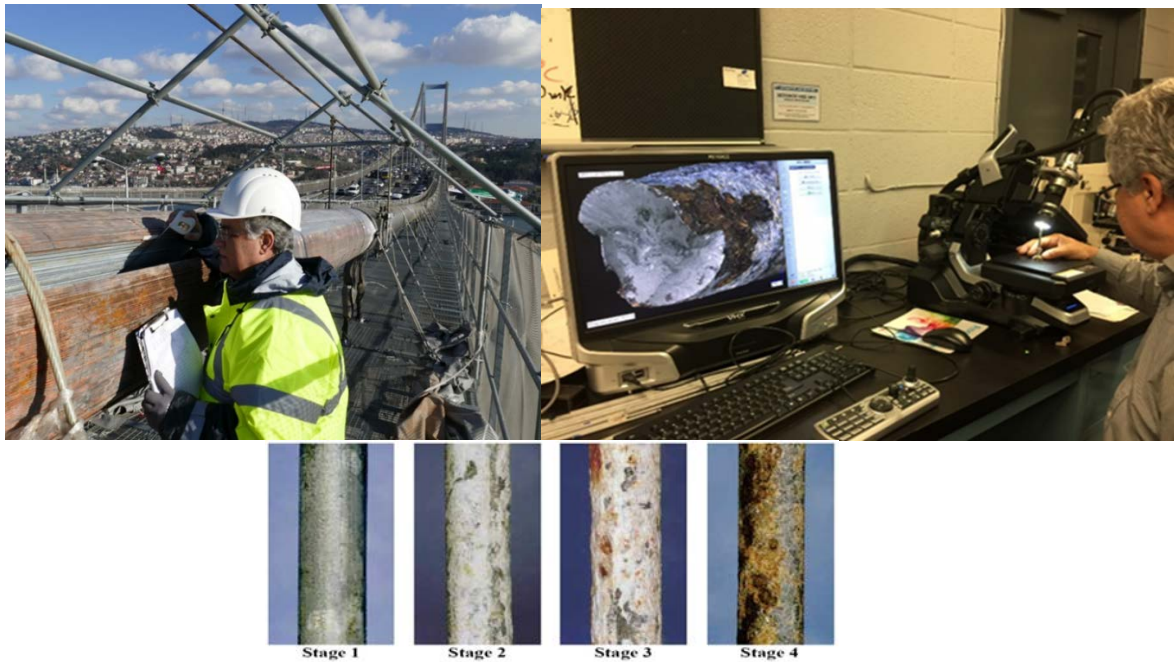
The cable interior was inspected at all locations and photographic documentation of each of the grooves was performed to document the corrosion condition deep within the cable. In addition, wire samples representing the various corrosion stages were extracted from within the cable for testing per NCHRP Guidelines report 534 with additional advance analysis and testing for fracture, fatigue and hydrogen effects. (See Figure4)

Figure 4: Main cable inspection and laboratory wire corrosion testing

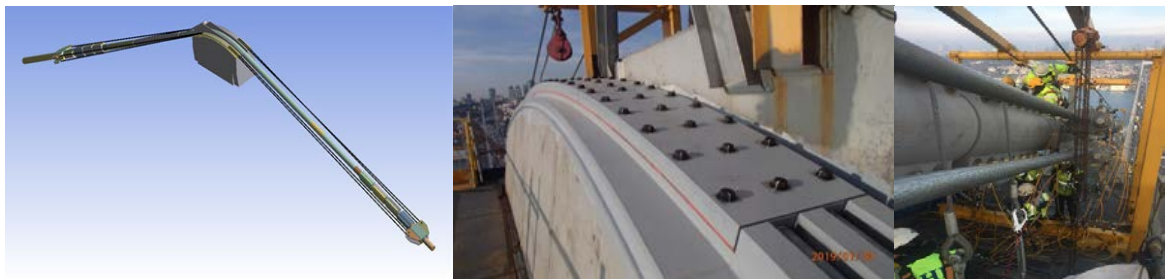
1. The worst condition was limited to the segment of cable near the tower. It was determined that splicing the 62 broken wires near the saddle was not feasible and did not fully restore the original main cable factor of safety of 2.2, due to significant loss of strength and ductility of the rest of unbroken corroded wires. These wires with advance stages of corrosion 3-4, are 2-3 layers deep into the cable totalling 850 -1100 wires. The main culprit for these broken wires was corrosion-induced hydrogen embrittlement and stress corrosion cracking. This resulted in reduction of the factor of safety to a low level of 2.0. Testing of the broken wires at revealed high level of hydrogen. As such, it was recommended to reinforce the main cable locally by installing an auxiliary bypass system to restore its capacity. See Figure 5.

Figure 5 : Main cable auxiliary bypass system of locked coil strands at tower locations

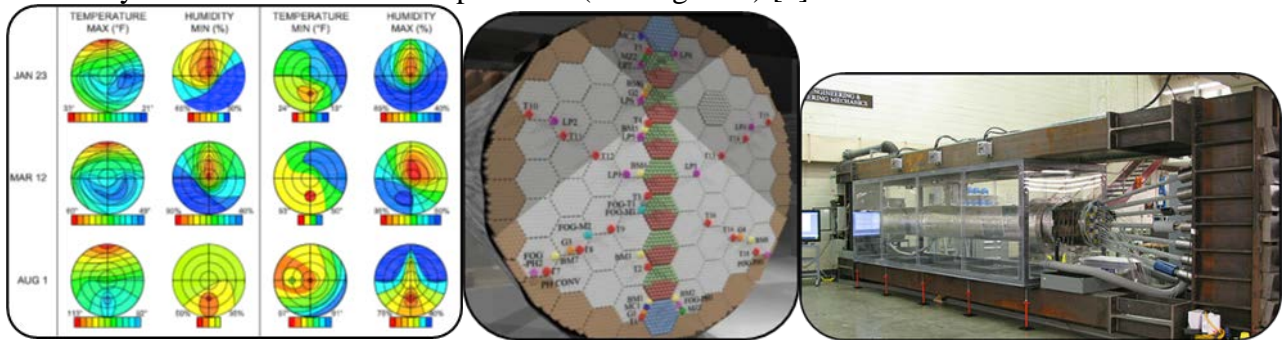
To stop further corrosion in the future and preserve the current factor of safety it was decided to design a state-of-the-art dehumidification system which was developed by Parsons in collaboration with Columbia University. The system consists of dry air injection ports at predetermined locations including the anchorage chambers. A main cable dehumidification system was installed as part of the new cable protection system. The design and function of the system was based upon the latest research and testing performed by Parsons in conjunction with Columbia University in New York City on a full size cable test specimen. (See Figure 6) [2]

Figure 6: Cable corrosion research and dehumidification utilizing internal sensors on full scale cable mock-up at Columbia University

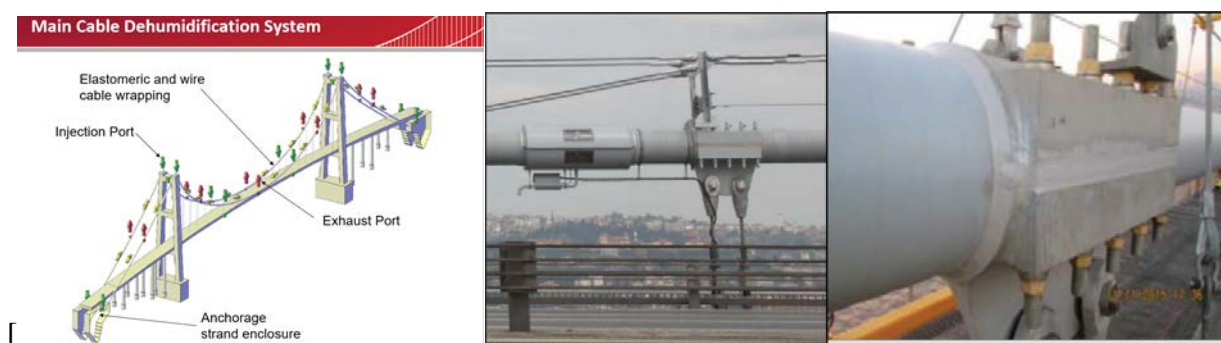
The system has injection ports at the anchorages, towers and main span third points. Exhaust ports are located at the back-span mid points, the main span midpoint, and the main span quarter points. The dehumidifiers are located in the anchorages, tower top struts and the box girder. In the anchorages, the cable strands are in an enclosure consisting of polyethelene sheets supported by tensioned strands. (See Figure 7) This reduces the volume of air needing dehumidification and makes the system more efficient.[3]

Figure 7: Dry air injection and exhaust port locations and air-tight elastomeric wrapping /sealing

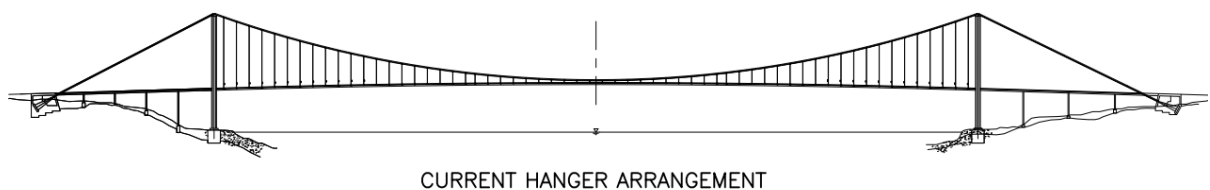
Figure 9: final bridge configuration with vertical hangers

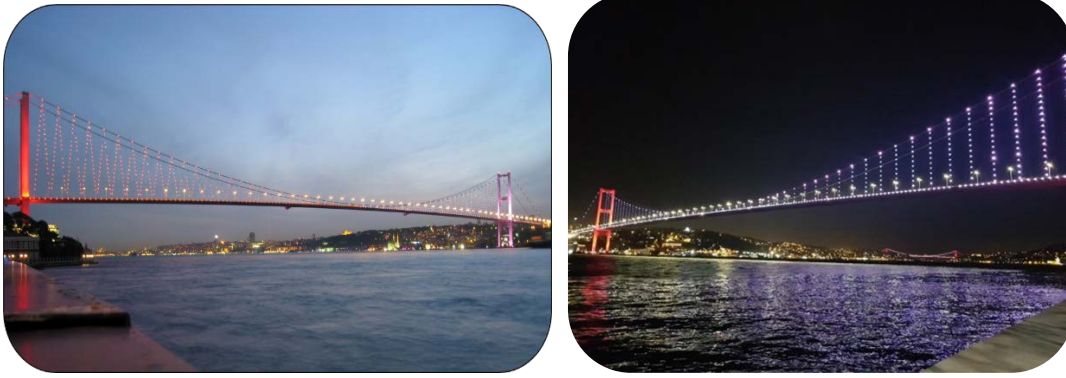
Figure 9: Original inclined hangers and new vertical hanger configurations show good aesthetics

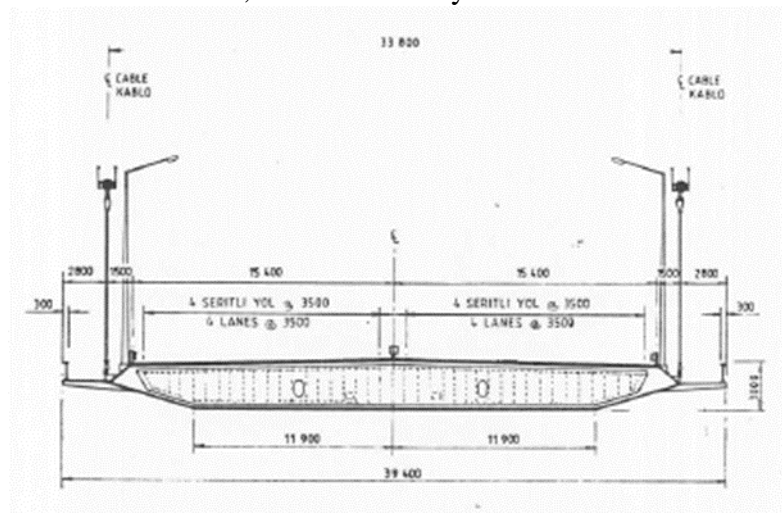
Figure 10: FSM Bridge Cross Section

The Fatih Sultan Mehmet (FSM) Bridge was completed in 1988 and was the second bridge over the Bosphorus Strait (see Figure 2). It has a main span of 1090m and was the 15th longest suspension span bridge in the world at the time. There is no suspended side span on the bridge. The overall width of the bridge is 39.4m and it carries four (4) lanes of traffic in each direction (see Figure 2 and Figure 3). The average daily traffic is about 200,000 vehicles/day.

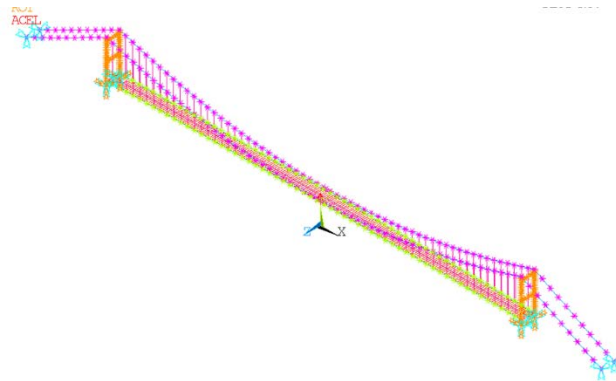
A global finite element (FE) model of the FSM bridge was developed to analyze the structural response to the design loads and calculate the design forces on the hangers under the various updated loading scenarios such as live load, wind and current seismic criteria including accidental hanger loss were investigated. (see figure 11)

Figure 11. Global 3D model using ANSYS for various load cases per Euro&AASHTO Codes

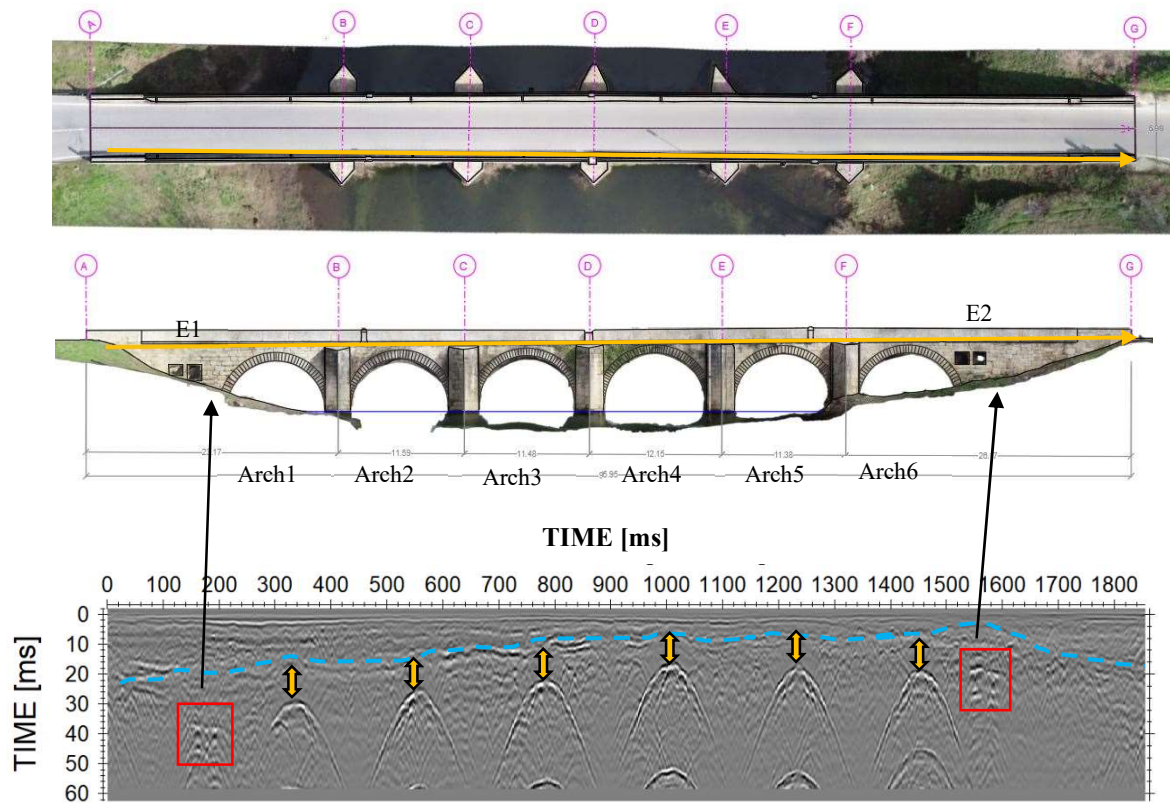
Aligned with each arch (on bridge geometry), the radargram shows the hyperbolas from the top and bottom of each arch (yellow arrows indicates the ring stone thicknesses). The hyperbolas are characterized by: i) high amplitude wave on the bottom of the vault ashlar, at the interface with the air; ii) lower amplitude wave (inside of ring stone of the arch) and iii) another high amplitude wave, at the bottom of the ring stone, at the interface with air. The GPR wave travel time between the top and the bottom of the ring stones were measured (RS in Table 1) and compared with the real thickness of the ring stones from photogrammetry (L1 in Table 1). Similarly, the travel time of electromagnetic waves between the pavement surface and the location of the top of rings stone was measured (T1 in Table 1) and then compared with the real thickness from geometry (L2 in Table 1). The wave velocity and the dielectric constant for each section at arch were then calculated. Theses parameters can provide information on the conservation status inside the bridge and enable the location of pathologies.

Figure 2: Radargram processed from profile 1 and bridge geometry near right bridge (edge).

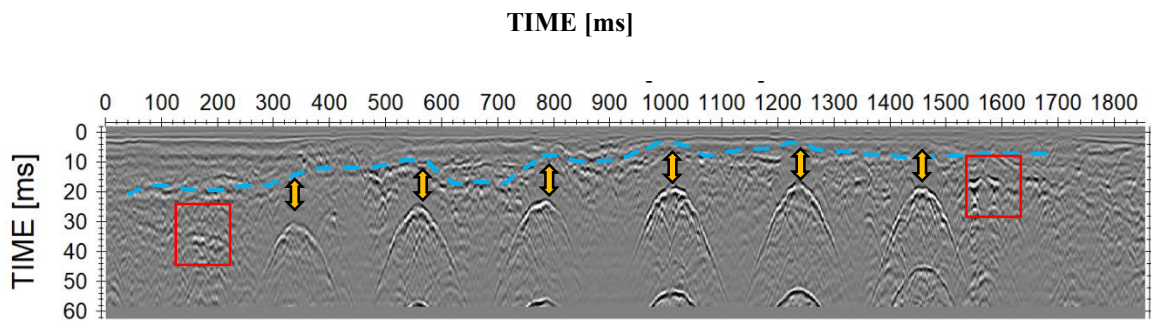
Figure 4: Radargram processed from profile 3 near left bridge (edge).

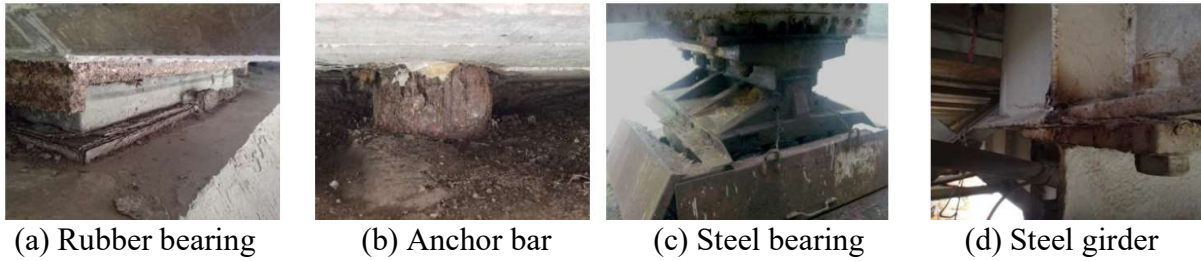
Figure 1: Corrosion Damage in Bridge Bearings Installation Area

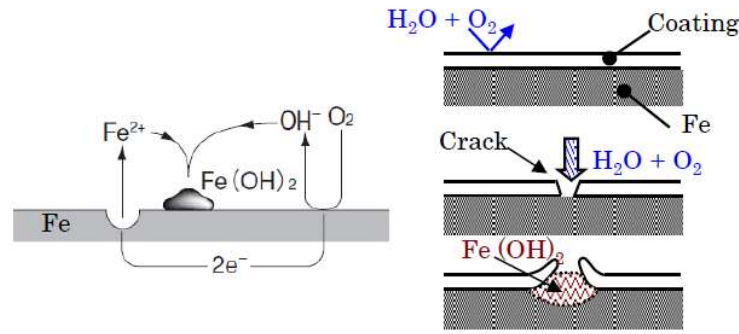
Figure 2: Mechanism of Rust Formation

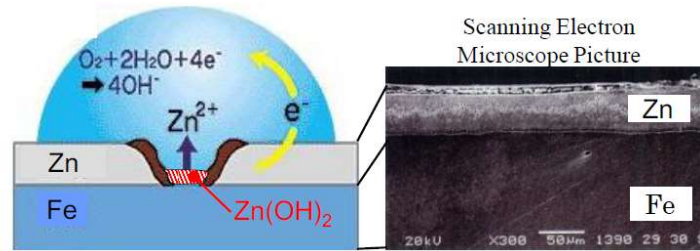
However, when steel is coated with a more reactive material, like zinc in the case of hot-dip galvanizing, rust develops faster in the coating, as described in Fig. 3, providing sacrificial protection.

Figure 3: Sacrificial Protection

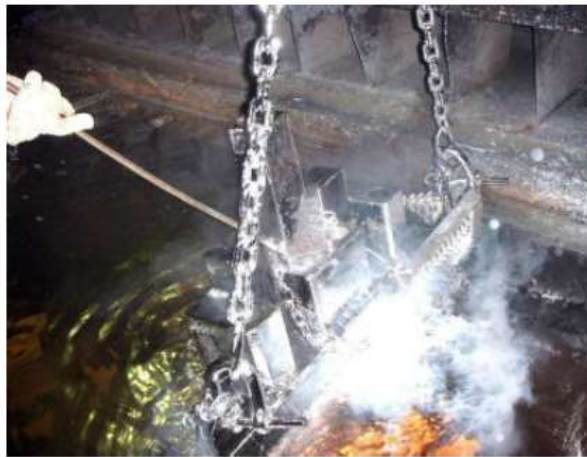
Figure 4: Hot-Dip Galvanizing

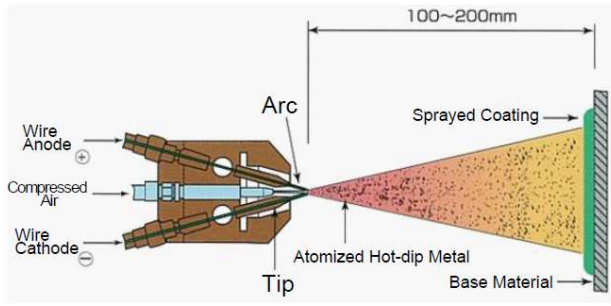
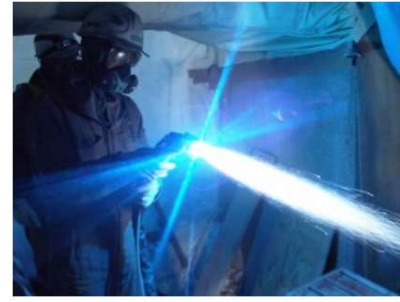
(a) Scheme of thermal spraying technique

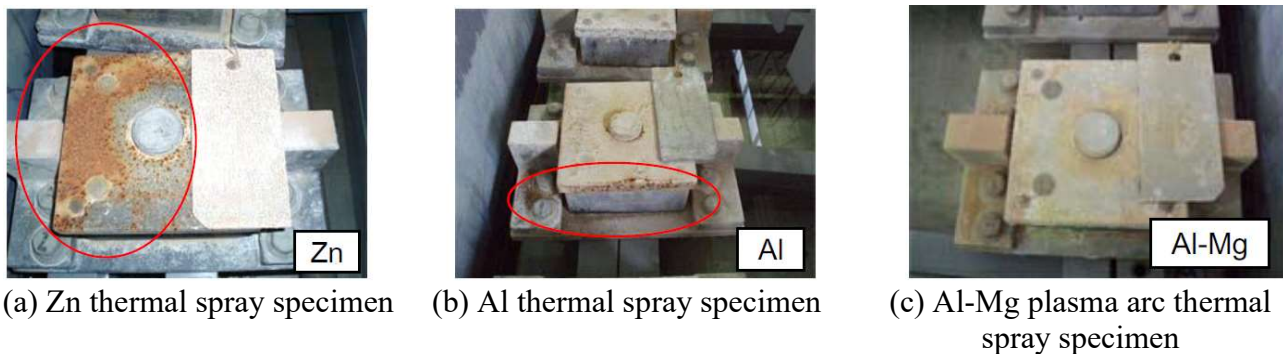
Figure 7: Results of the corrosion test to bearing models

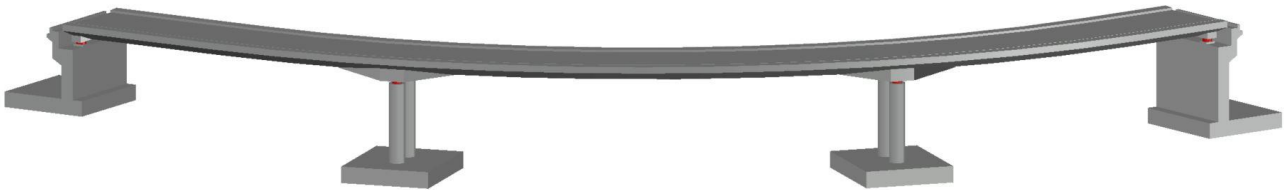
Figure 2 Three-dimensional drawing of the bridge

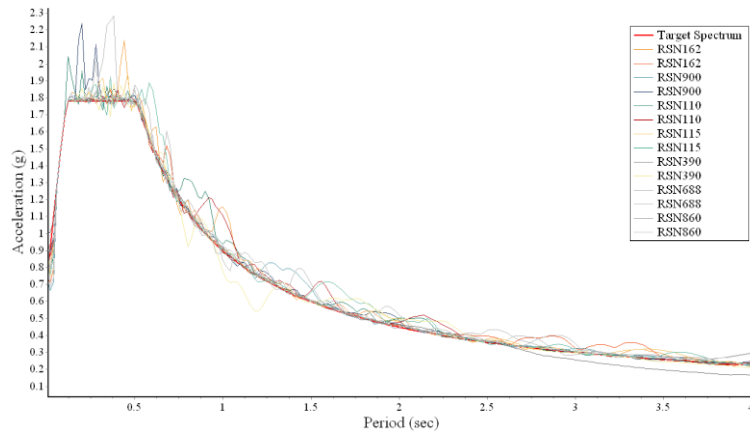
Figure 4 Response Spectra of Scaled Records

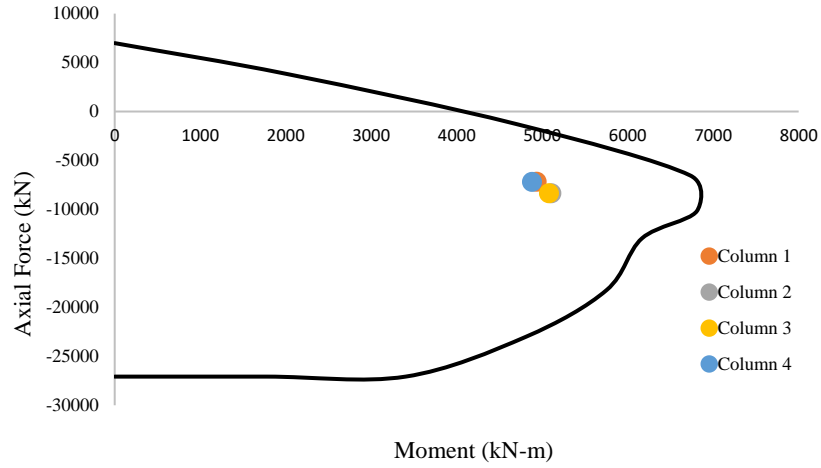
Figure 5 P-M Interaction Diagram for Column Cross Sections

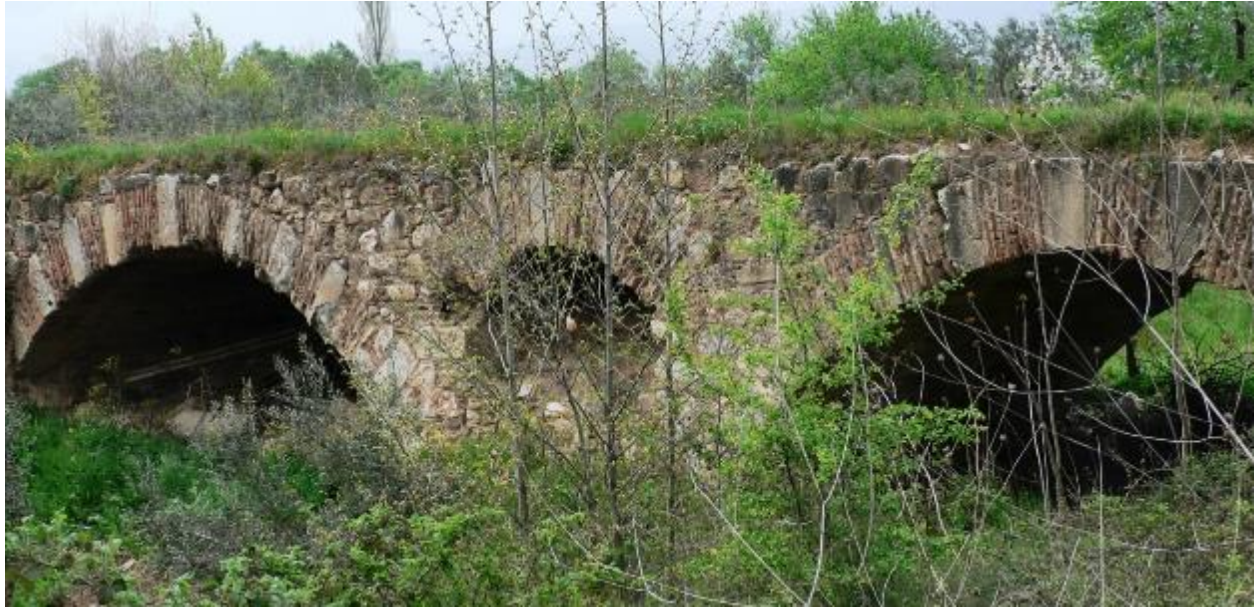
İnikli Bridge in İznik (Photo: Kantaratlas-2005)

The bridge is nearly sunk in vineyard nowadays. It belongs to a unique group of bridges with its alternating brick and stone arches and this feature continues for the entire width of each arch. This type of construction is typical of the Byzantium period dated from 500-600, with similar examples in the vicinity.

More importantly, the bridge arch is segmental and one of the earliest examples of this type. A Segmental arch is one with the rise smaller than the radius of the semi-circle arch. Thus providing more space underneath the bridge. The openings between the main arches reduce the weight and the amount of material.

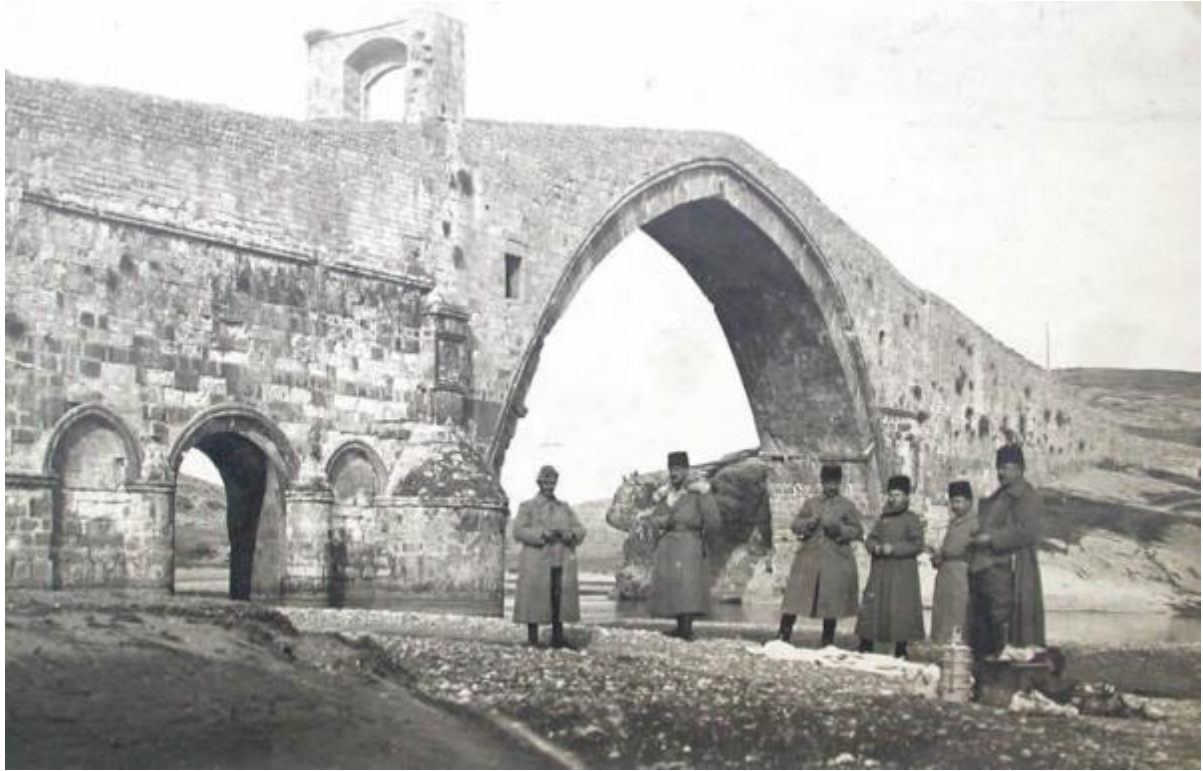
Malabadi Bridge - Year 1918 (Karabekir 2017)

Some of the Beyliqs already had their own techniques and cultures. One of these groups was the Artquids, a Turkmen dynasty that ruled in Eastern Anatolia. They left significant monuments and one is the engineering feat of the magnificent Malabadi Bridge with its clear span of 38.60m. It was constructed between 1145 and 1154 to cross the Batman River which leads to the river Tigris. (İlter, 1978)

The chambers on either side were incorporated mainly to reduce weight on the arch. Stairs provide access to these rooms via an entry structure of a person's height on either end of the bridge. These rooms are 4.5 x 5.3m each; they have been home to travelers, fishermen, singers and also engineers who constructed the nearby bridge in 1956. (Köpriyet, 2014).

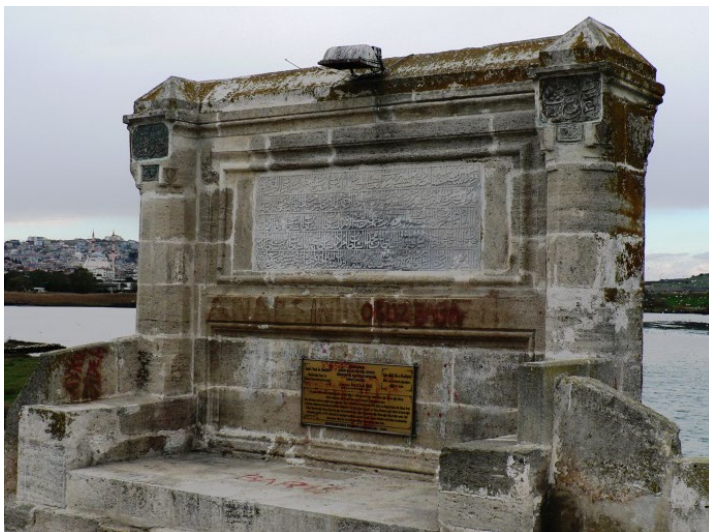
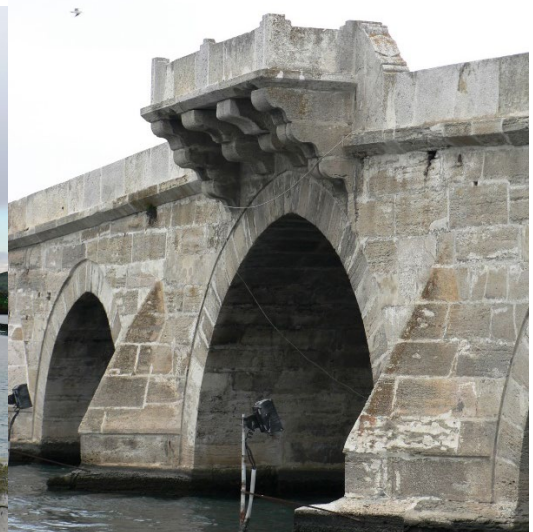
Büyükçekmece Bridge: Top: 4 Bridges connected with Islands, Left-Bottom: İncirpazarı Tower and Right-Bottom: Balcony Console Detail (Photo: Kantaratlas-2005)

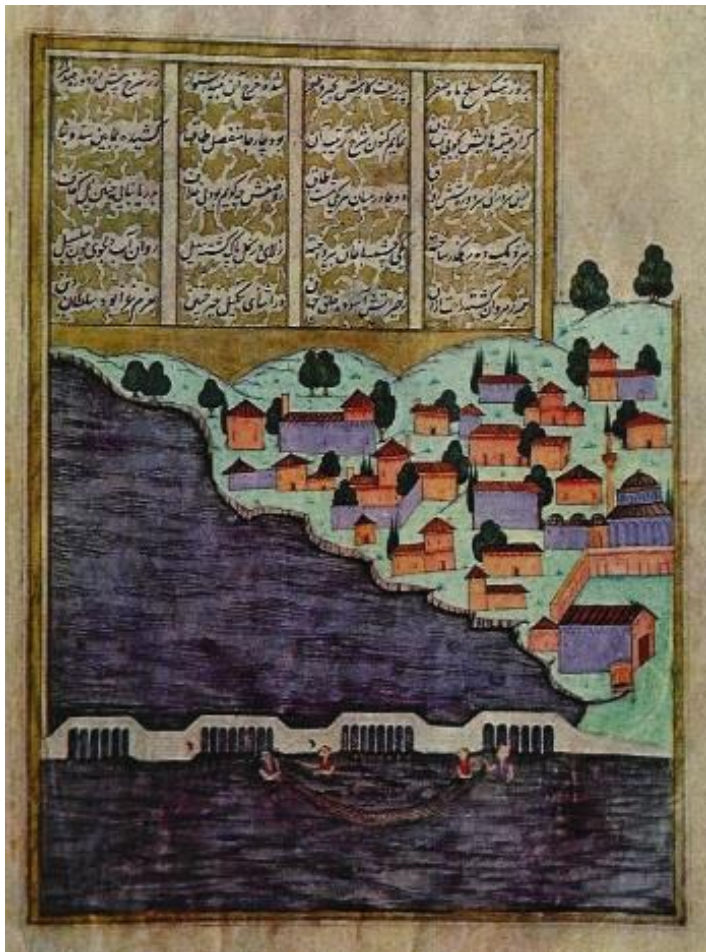
Büyükçekmece is a bridge in 4 parts each connecting on artificial islands which were also constructed as part of the bridge. This also provides leeway for excessive floodwaters with least obstruction. It shows typical examples of Ottoman bridge architecture with inscription towers, balconies and bollards at the entrances. The spans are crossed with pointed arches and piers are surrounded by pointed or rounded cutwaters. (Kantaratlas, 2014)
