ISTANBUL BRIDGE CONFERENCE 2020

"THE ENDURING LINK"

PROCEEDINGS

Bridge Analysis & Design & Construction

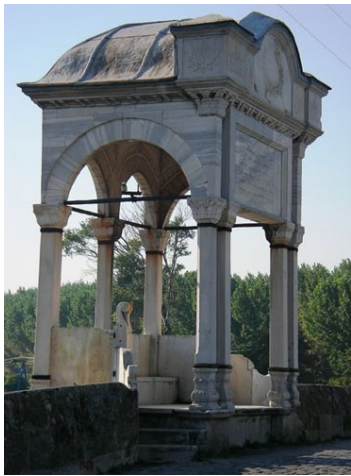
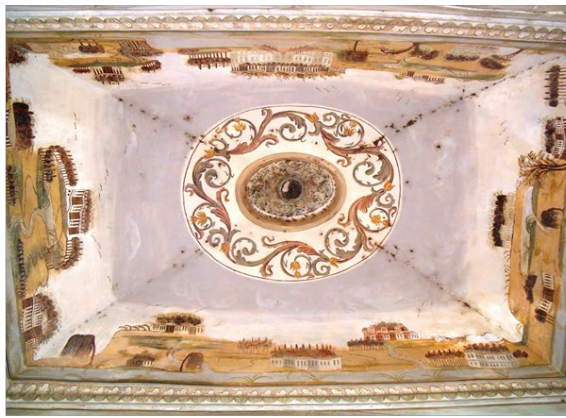
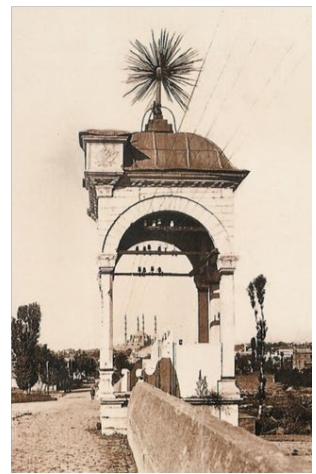
Meriç Bridge Inscription Tower Details and Ceiling (Photo: Kantaratlas-2005 and Internet)

The fall of the Ottoman Empire can also be marked with a bridge over the Maritsa (Meriç), in Edirne. Meriç bridge construction took over 10 years and the Sultan struggled to finance the project. The 1847 dated bridge presents the mature features of Ottoman bridges with cutwaters, bollards, drainage details and especially an impressive artwork that is the marble inscription tower. (Çulpan, 1975)

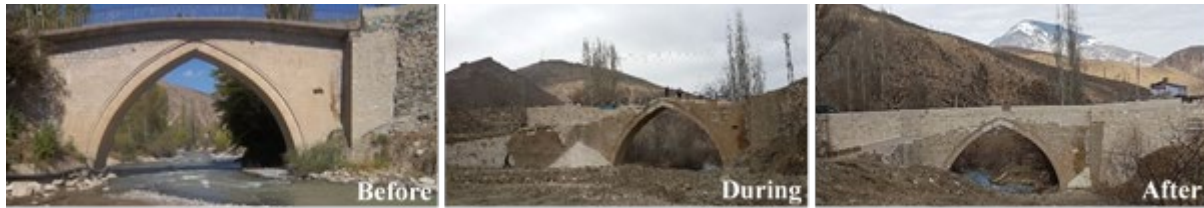
Figure 1: Views of Pehlivanlı (Kireçli) Bridge Before, During and After Restoration (Okuyucu et al. 2016)

The total slab length of the bridge is approximately 43.47m, the deck width is 5.60m, the height is 12.50m and the arch span is 15.17m. The cut-stone of the bridge was defined to be a very high strength rock; 150 MPa of compressive strength. (Okuyucu et al., 2016) The bridge has been restored by Turkish General Directorate of Highways in 2015. General views of the bridge are presented in Figure 1.

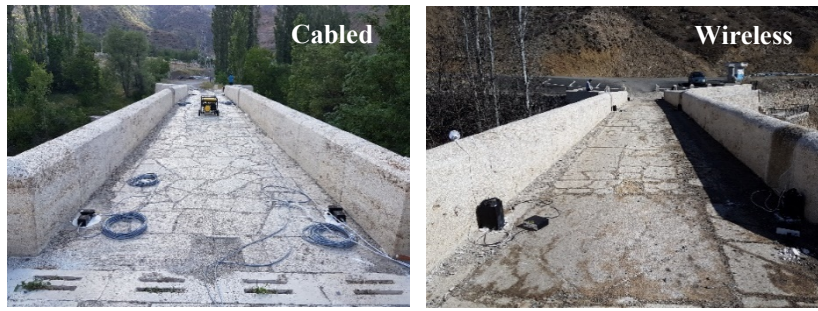
Figure 2: General Views from Accelerometer Instrumentation for Pehlivanlı (Kireçli) Bridge

In the case of Pehlivanlı (Kireçli) Bridge research, finite element model of the bridge was created and theoretical modal analysis was performed to calculate mode shapes and frequencies. The instrumentation plan was prepared for related degrees of freedom and a total of six points were selected to measure the structural response. Cabled accelerometers and ultra-high sensitive wireless accelerometer sensors were implemented to measure the structural response to ambient vibrations. General instrumentation views of the bridge are presented in Figure 2. It should be underlined that

cabled sensors were used for the last OMA application which was carried out almost two years after the restoration work. The measurement time was kept ~30 minutes for each data set.

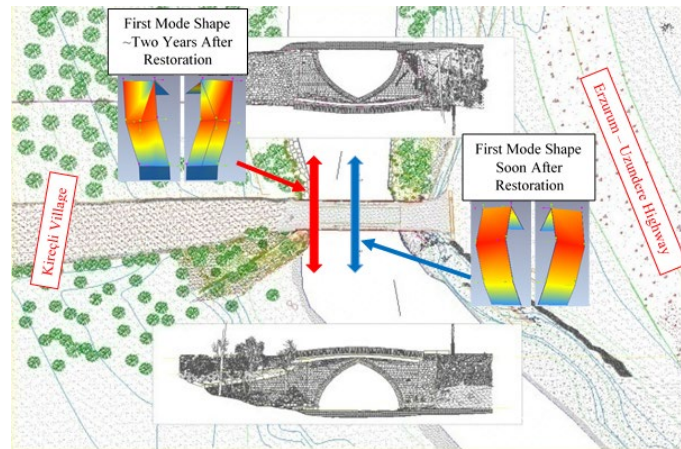
Figure 3: Schematic View of First Mode Shapes of Pehlivanlı (Kireçli) Bridge Soon and ~Two Years After the Restoration

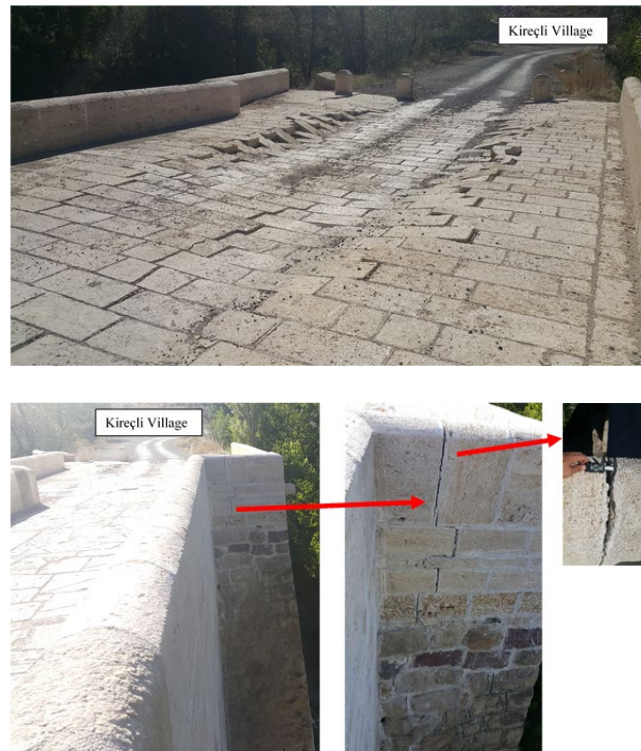
Figure 4: Damage Views from Pehlivanlı (Kireçli) Bridge on Kireçli Village Side

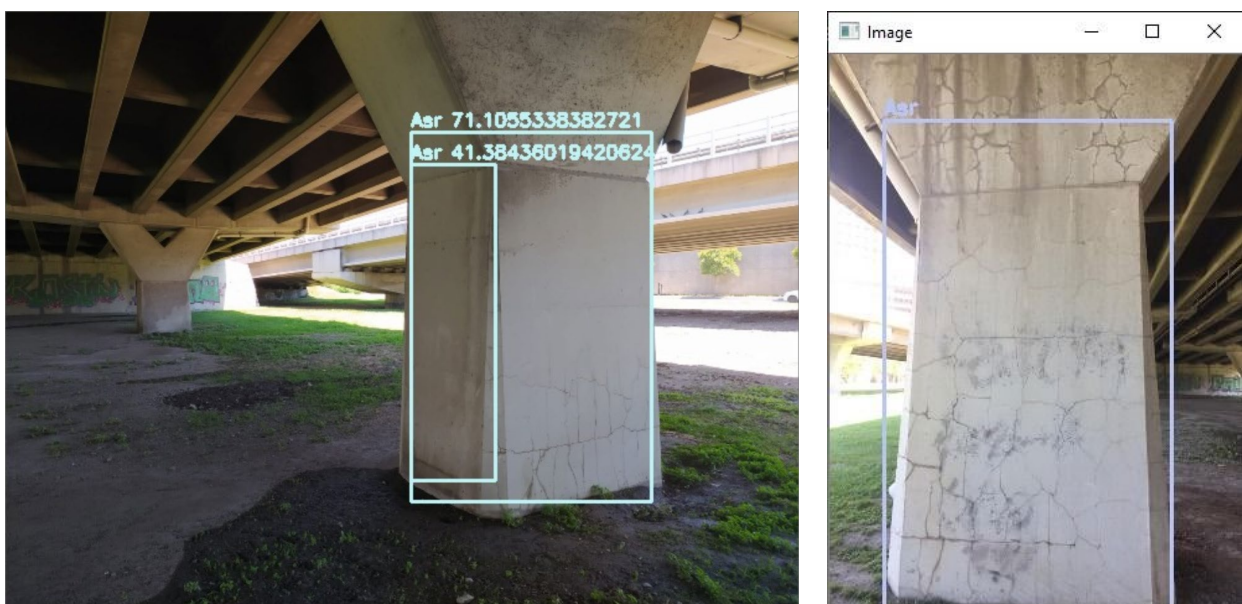
Figure 3 Bridgewiz Android Application

Bridgewiz Engineering is working on an Android application that will be used to identify different types of damage exposed on bridge components (Figure 3).
